# **INDOOR AIR QUALITY ASSESSMENT**

**Forbush Memorial Library  
118 Main Street  
Westminster, Massachusetts**

Prepared by:  
Massachusetts Department of Public Health  
Bureau of Environmental Health  
Indoor Air Quality Program  
December 2007

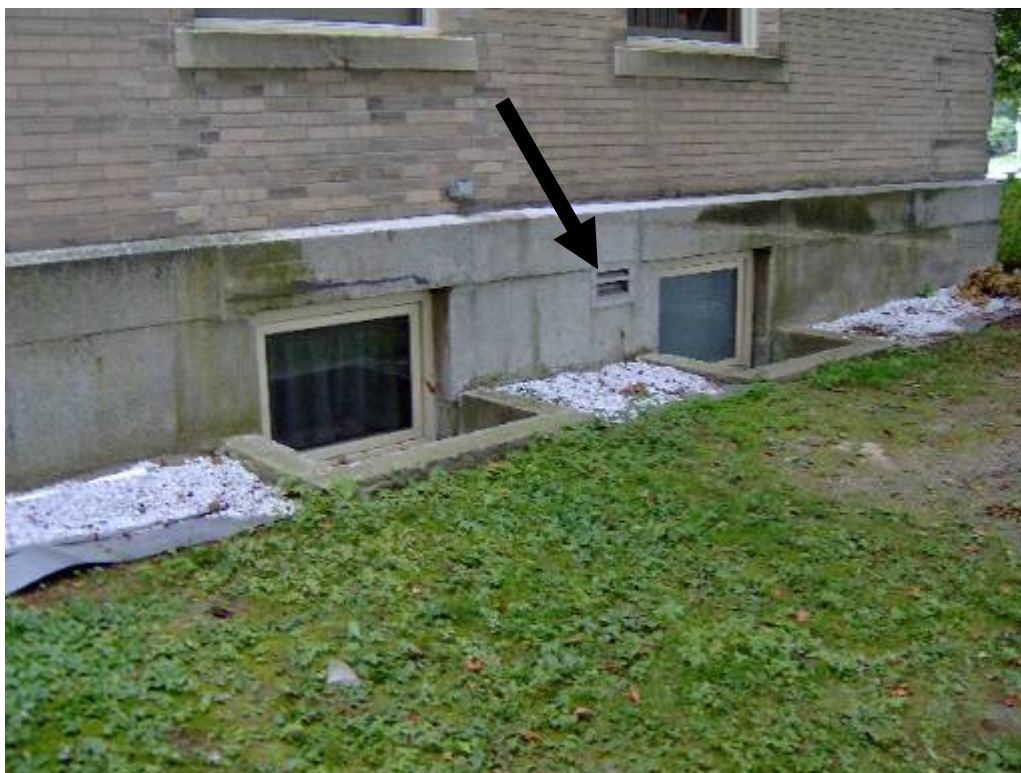
**Picture 3**

The 1901 portion of the FML was not originally designed with a mechanical ventilation system. When the building was renovated in 1997, a heating, ventilating, and air-conditioning (HVAC) system was installed. However, the system does not appear to have the capacity to introduce fresh air into the building, but rather recirculates air. BEH staff identified two ducts on the exterior of the building that are presumed to be exhaust vents for the restrooms (Pictures 3 and 4).

**Presumed Exhaust Vent, Original Building**

- f. Remove foliage to no less than five feet from the foundation.
- 8. Ensure restroom exhaust vents operate at all time during business hours.
  - 9. For buildings in New England, periods of low relative humidity during the winter are often unavoidable. Therefore, scrupulous cleaning practices should be adopted to minimize common indoor air contaminants whose irritant effects can be enhanced when the relative humidity is low. To control for dusts, a high efficiency particulate arrestance (HEPA) filter equipped vacuum cleaner in conjunction with wet wiping of all surfaces is recommended. Avoid the use of feather dusters. Drinking water during the day can help ease some symptoms associated with a dry environment (throat and sinus irritations).

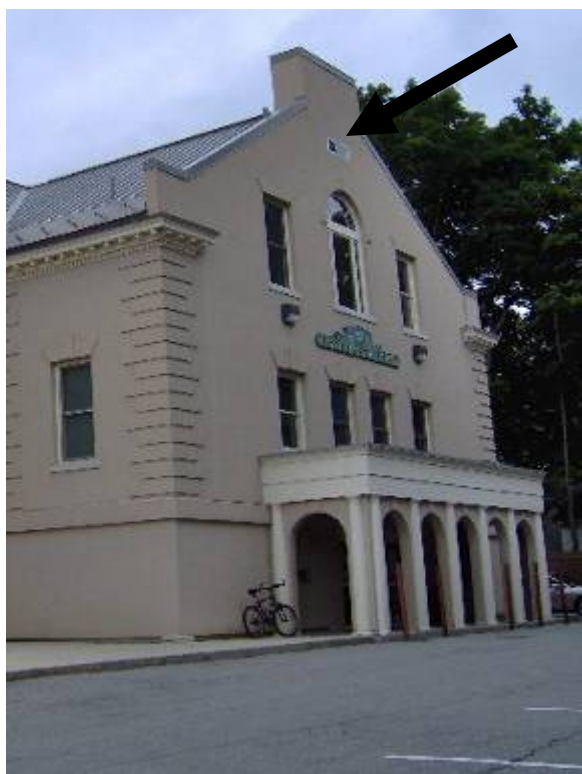
**Picture 4**

**Presumed Exhaust Vent, New Wing**

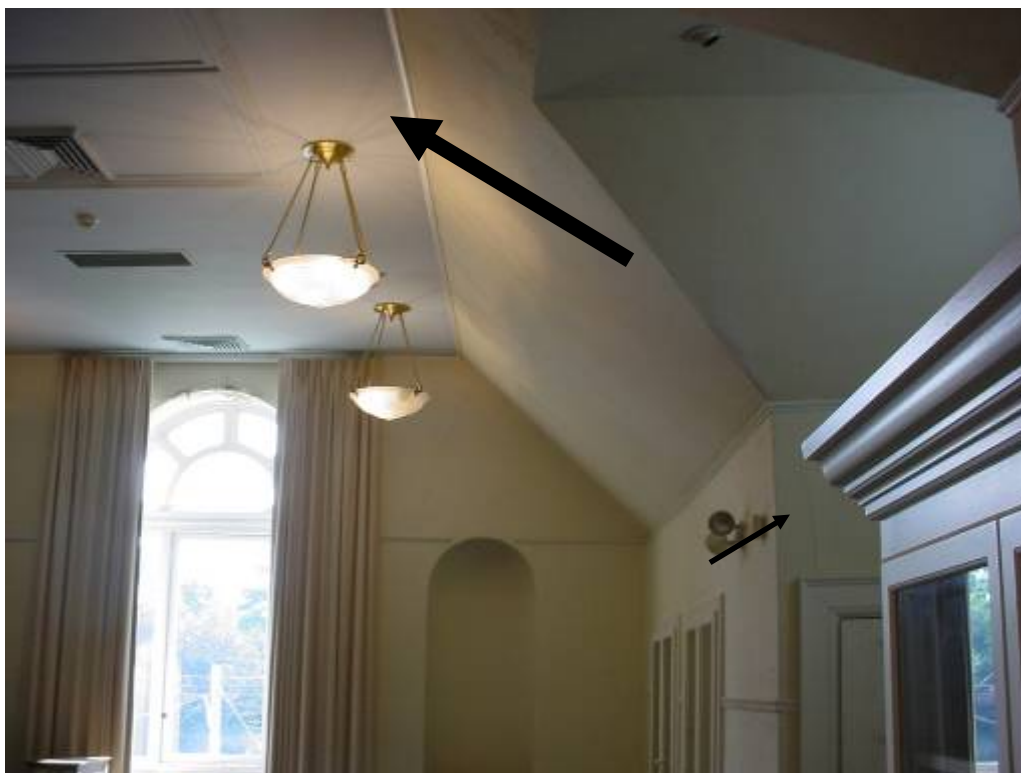
**Picture 5**

**False Ceiling below AHU, Note Crack above Doorway**

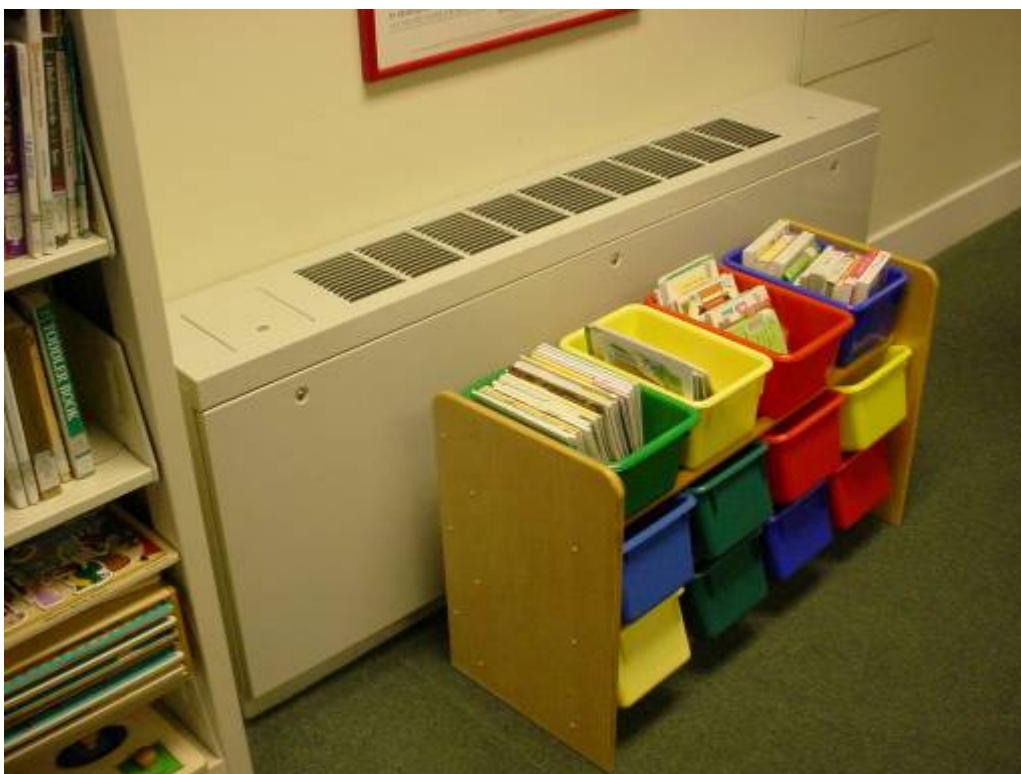
**Picture 6**

**FCU**

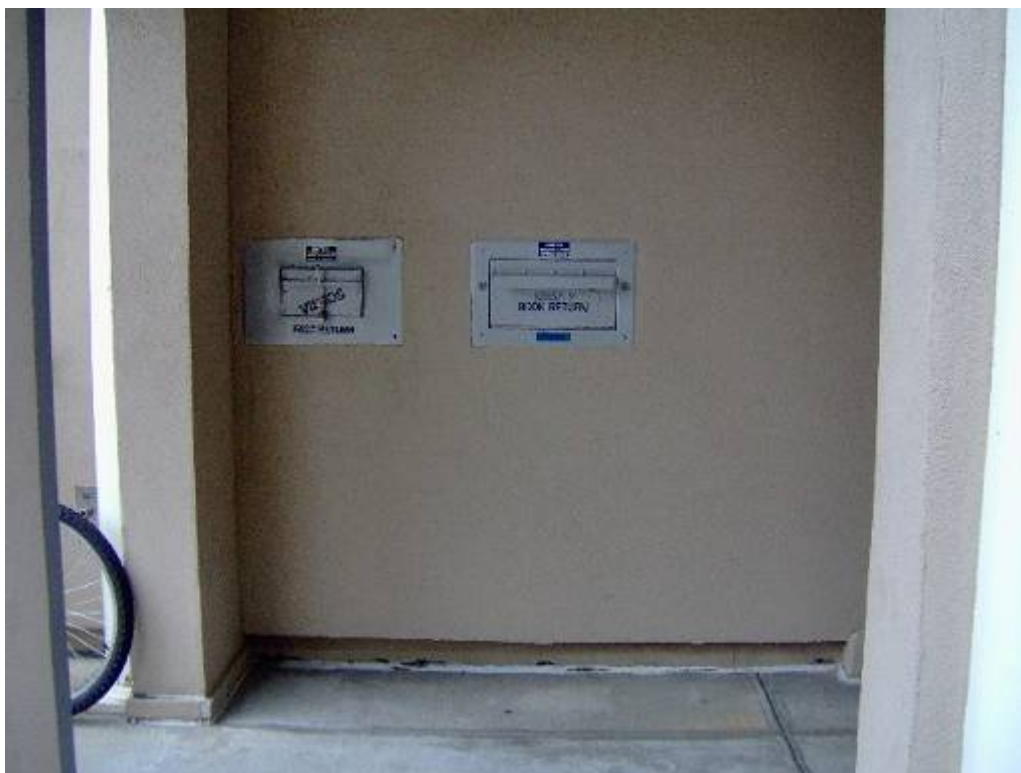
**Picture 7**

**Book Drop**

5. Ensure all water service pipes are properly insulated with a material of a sufficient R Rating to prevent condensation.
6. Seal the book drop opening with appropriate materials to prevent unconditioned air from penetrating the building.

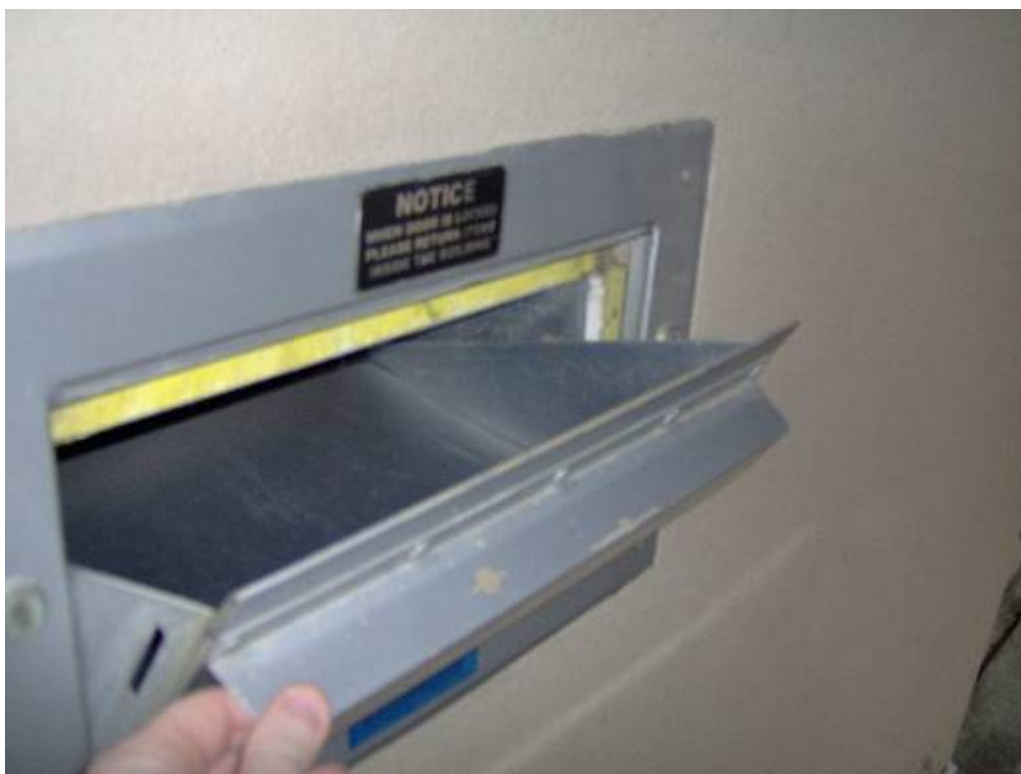
**Picture 8**

**Book Drop Interior, Note Space in Wall and Lack of Gaskets to Prevent Air Penetration**

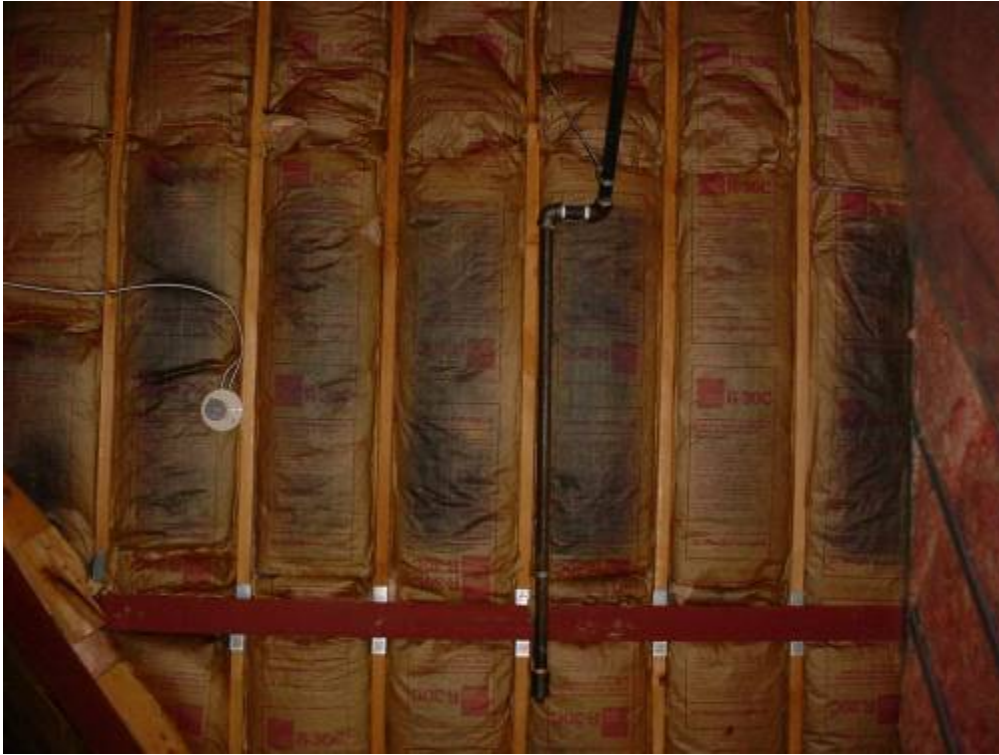
**Picture 9**

- Lack of weep holes exist on the exterior wall;
- Lack of drainage plane behind the substrate;
- Fiberglass insulation batts were in direct contact with the substrate (Picture 9); and
- Fiberglass insulation was enclosed using clear polyethylene plastic sheets (Picture 10).

Considering these observations, the EIFS system installed in the 1997 wing of the FML is most likely a barrier system which has little or no means to drain water from the wall system.

**Fiberglass Batts In Contact With EIFS Backing With Plastic Removed, Note Blackening Of Paper, Indicating Possible Mold Growth**

2. Continue with efforts to evaluate the exterior wall of the 1997 wing to provide adequate water drainage from the wall system. Based on BEH staff observations, these efforts likely include installing a full drainage plane with weep holes beneath the EFIS walls and proper flashing around all windows and door frames. Please note that the only feasible manner in which to install a proper drainage plane behind the EFIS would be to remove the entire existing system.

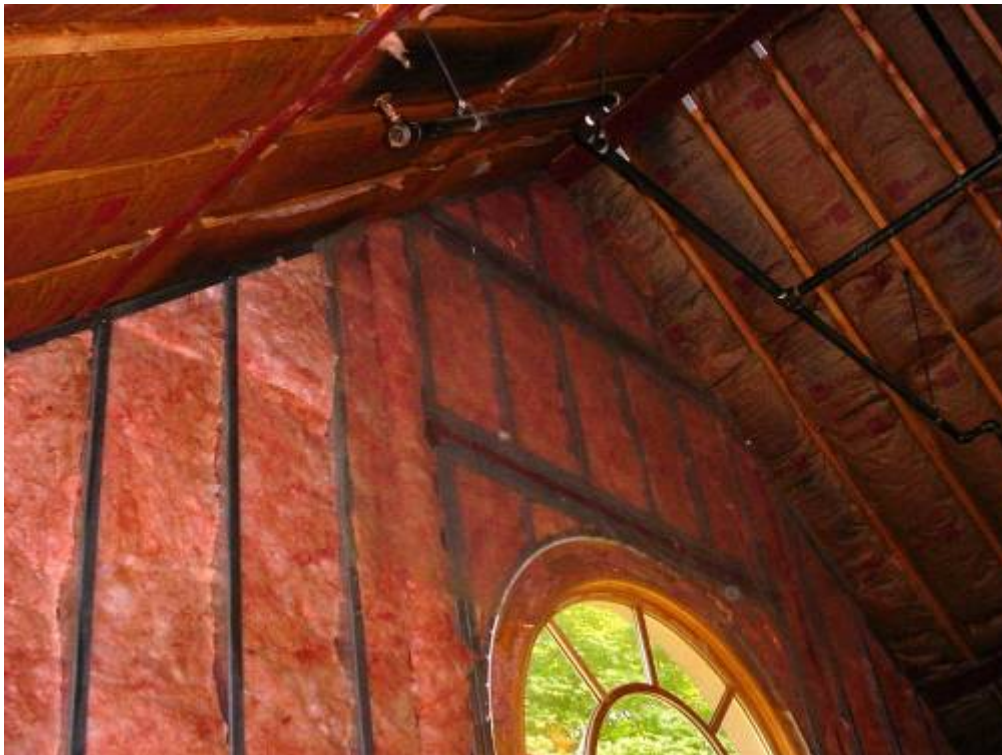
**Picture 10**

**Insulation Sealed Behind Polyethylene Plastic**

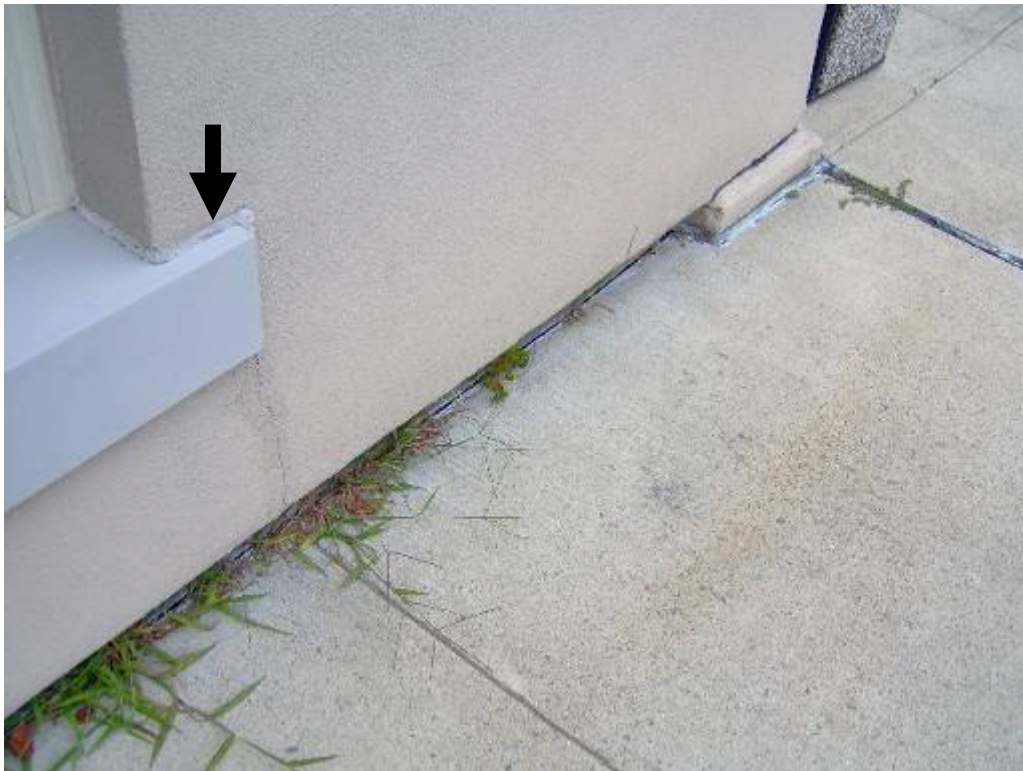
**Picture 11**

- Failure to install or properly install sealant joints around windows, doors, pipes, conduits, and other penetrations of the field of the EIFS.
  - As noted by FML maintenance staff, windows in the 1997 wing were observed to leak in wind driven rain weather conditions.
- Failure to flash window and door openings in the field of the EIFS to divert leakage through the window or door to the exterior.
  - Windows of the FML did not appear to have flashing. Spaces between window frames and EIFS panels were sealed with caulking (Picture 11).
- Failure to properly backwrap edges of EIFS at terminations and penetrations in the field of the EIFS.

**Window frame Sealed with Caulking in EIFS, Instead Of Flashing**

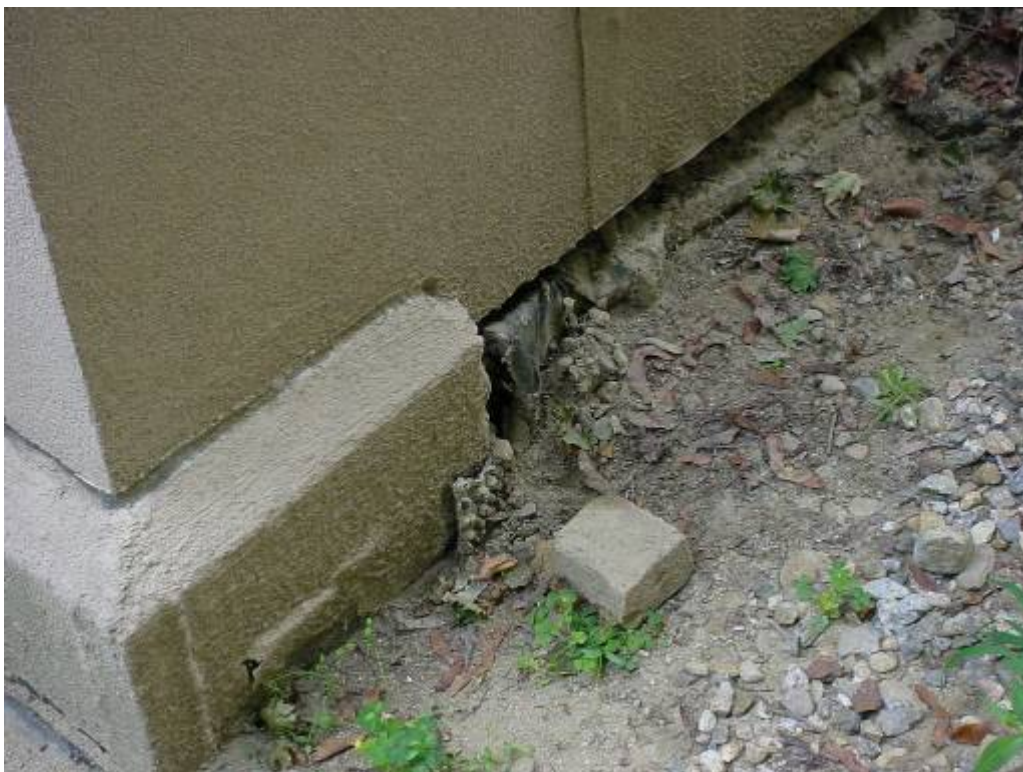
**Picture 12**

- Spaces were noted along the slab/EIFS junctions that appears to expose the vapor barrier to the outdoors (Pictures 12 and 13)
- Failure to terminate EIFS above grade, especially in termite prone regions.
  - It appears that the EIFS system on the west wall of the 1997 addition is actually buried beneath soil and leaves (Picture 14). In addition, the ground next to this wall is actually sloped *toward* the FML, subjecting the west wall to repeated moistening from rainwater.
- Un-repaired impact damage.
  - A number of locations appear to have damaged basecoat that exposes the underlying insulation boards (Pictures 15 through 16).

**Exposed Vapor Barrier, West Wall**

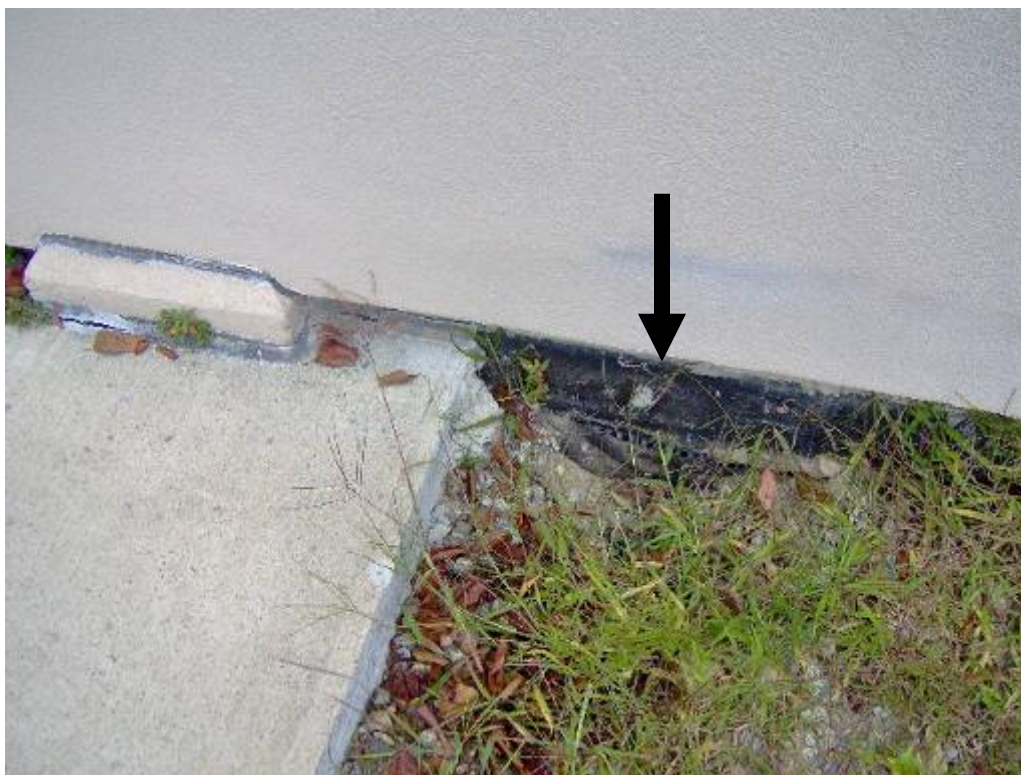
**Picture 13**

**Exposed Vapor Barrier, East Wall**

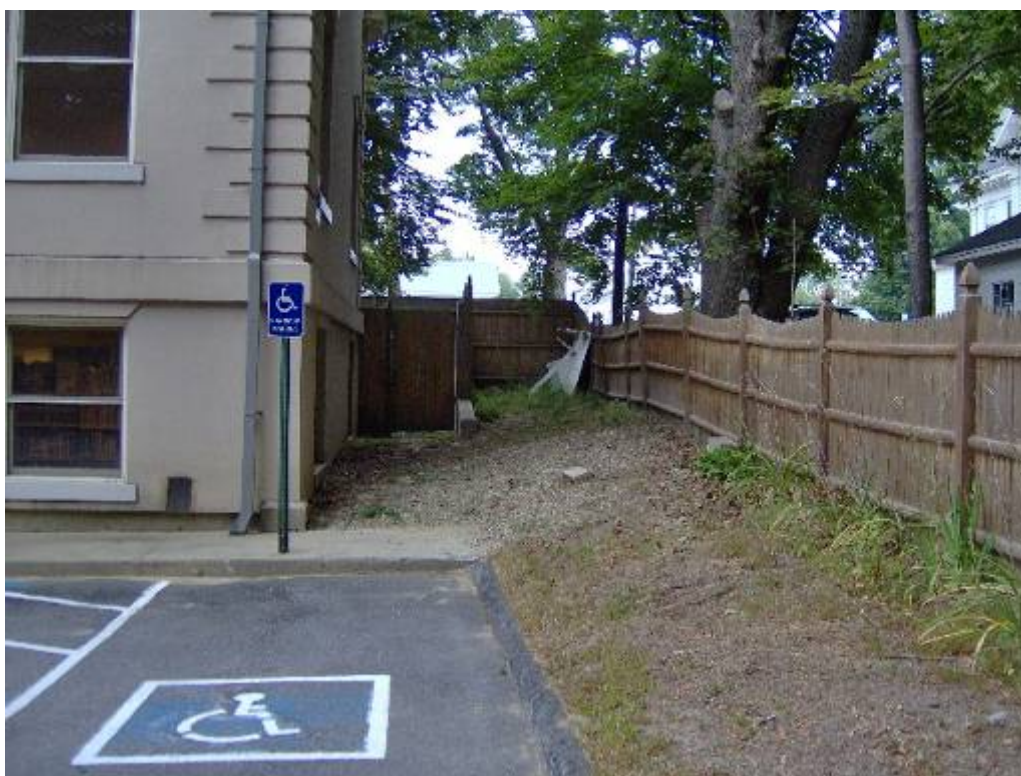
**Picture 14**

As previously discussed, the west wall of the 1997 wing is buried beneath soil. It appears that the ground at the junction of the original building and the 1997 wing is sloped towards the building. There does not appear to be any means for draining water (Picture 26).

**West Wall, New Wing, Buried Beneath Soil That Is Sloped Towards the Building**

3. Re-grade the area around the west wall of the library to both unearth the slab and exterior wall of the 1997 wing and direct water away from the building.

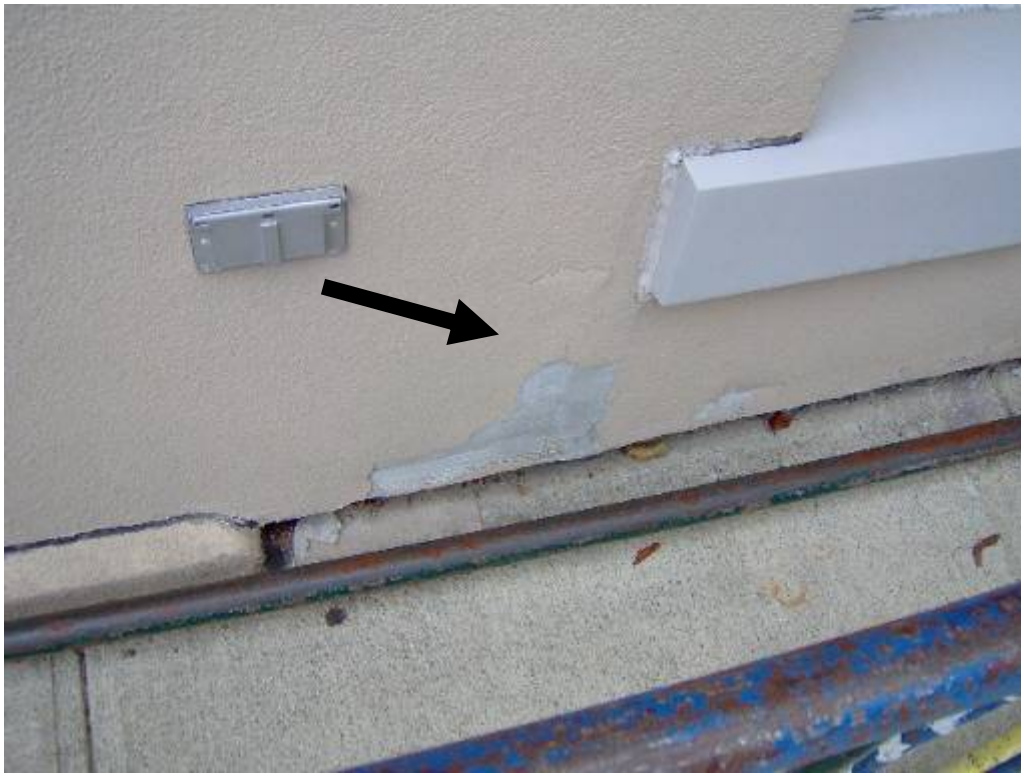
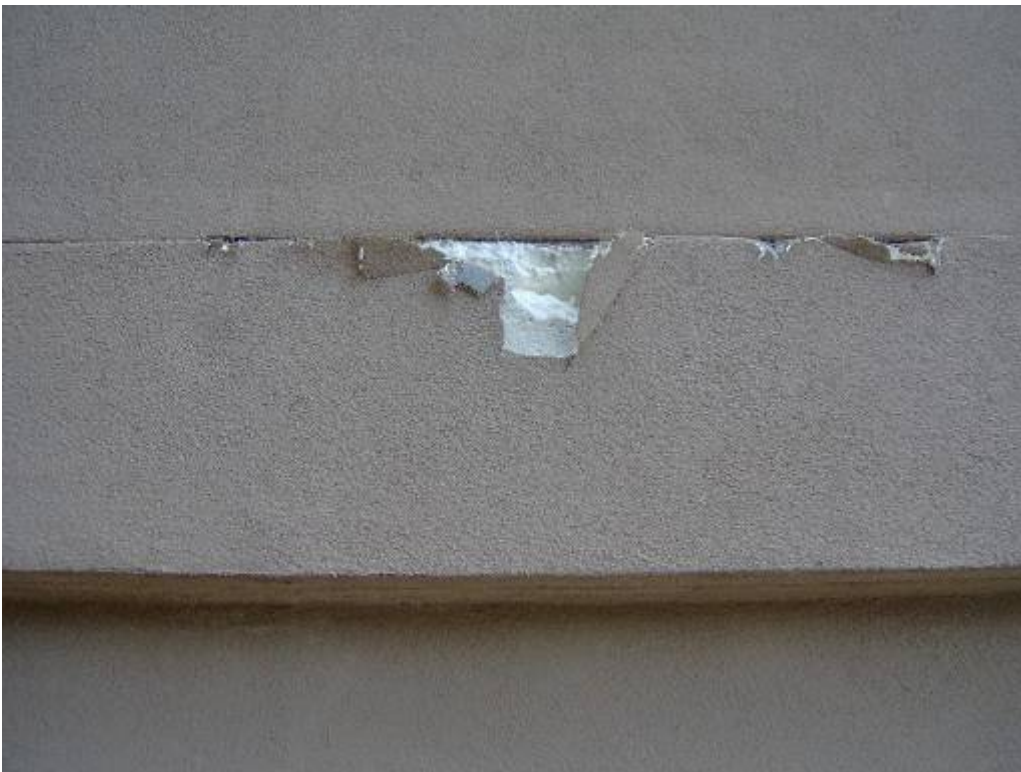
**Damaged Basecoat That Exposes the Underlying Insulation Boards**

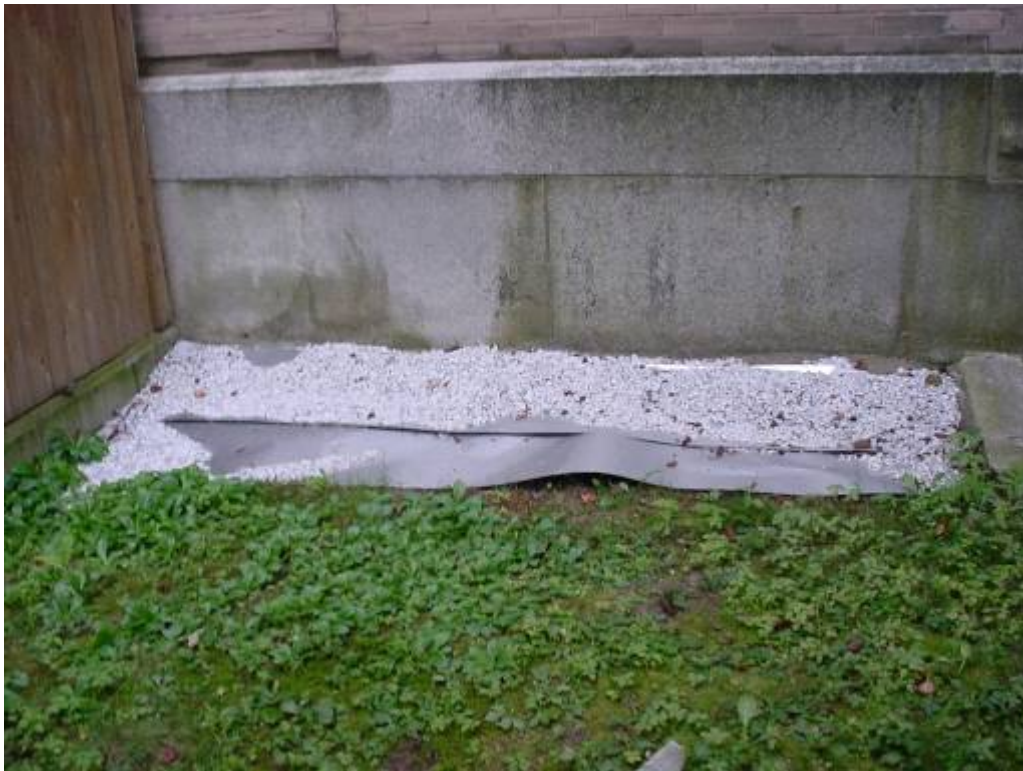
**Picture 17**

Water damage was also noted in the children's restrooms, which were retrofitted in the original building's basement as part of the 1997 renovation. Air in the restrooms was stagnant due to deactivation of the restroom exhaust vents. BEH staff detected a musty odor in the restrooms. BEH staff agitated the gypsum wallboard (GW) beneath the restroom windows, which produced a strong musty odor. This indicates probable mold colonization within the wall cavity formed by the GW and the original foundation wall. The source of moisture causing damage to the restroom GW is likely water penetrating through the foundation wall and/or the restroom window frames. Water penetration in this location appears to be a chronic issue. In an effort to divert rainwater from the ground outside the restrooms, a series sheet metal pieces was placed on top of the soil at the foundation wall of the original building (Pictures 17 and 18). For the following reasons, these sheet metal

barriers are not only ineffective in draining rainwater away from the foundation, but its presence likely enhances moisture penetration through the foundation, resulting in chronic water damage to the restroom GW:

- The individual sheets of metal are not joined to create a continuous apron, leaving seams that allow water to penetrate to the soil/ground.
- The sheet metal is actually sloped toward the building, which will enhance water pooling and subsequent moisture penetration.

- The sheet metal serves to keep the soil around the foundation moist in a manner similar to a wood chip covering.
- The restroom windows are located in cement-lined pits (Pictures 20 and 21).

**Sheet Metal on Soil West Wall**

7. Remove sheet metal from the foundation base of the west exterior wall of the original building. Consider the following actions to prevent moisture penetration into the basement:

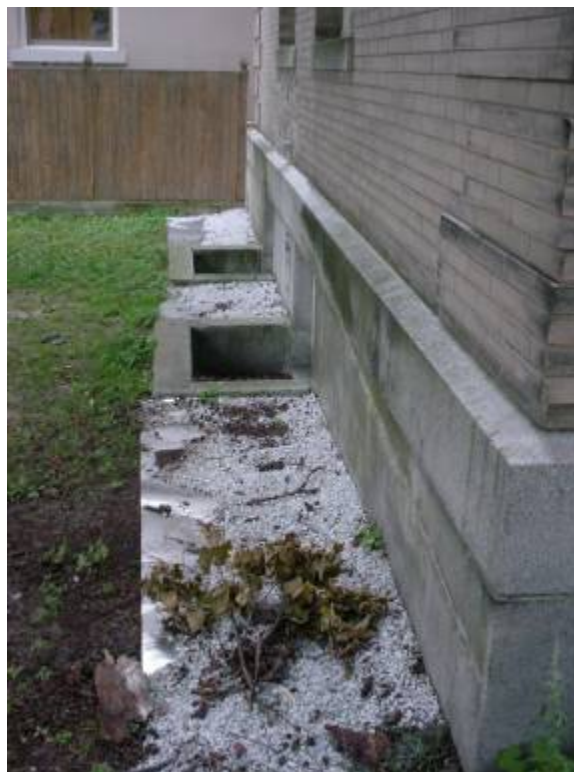
**Picture 18**

**Sheet Metal on Soil, West Wall**

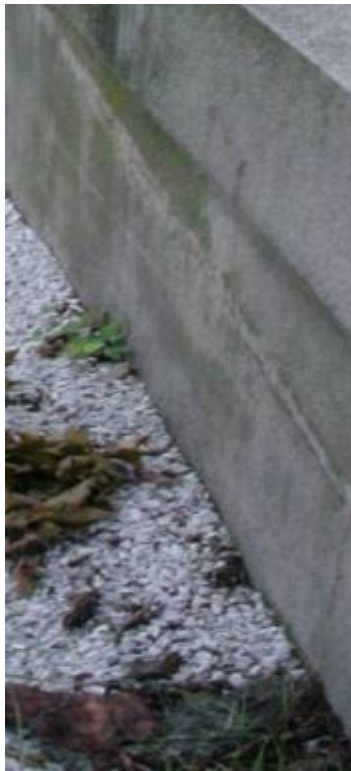
**Picture 19**

- The sheet metal is not attached to the building in a manner that prevents water penetration between the foundation and the metal covering (Picture 19)

**Seam between Sheet Metal and Foundation Wall, Note Curl of Sheet Metal Away From Wall**

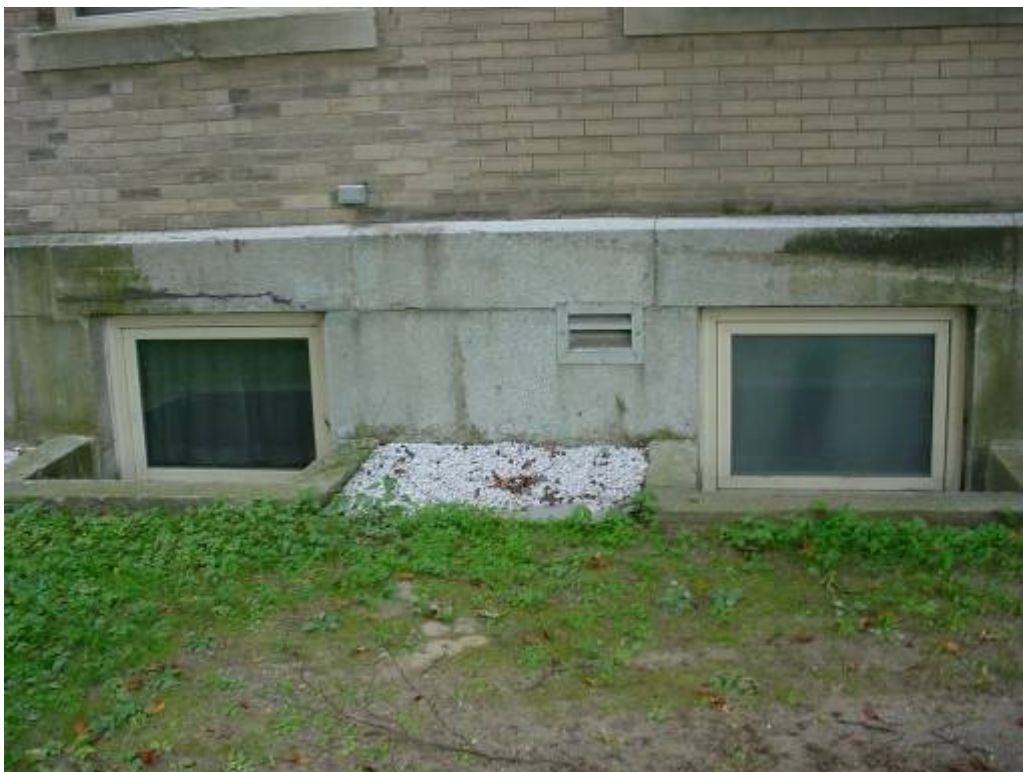
**Picture 20**

Cracks have formed below seams where the cement slabs and foundation walls are joined, allowing groundwater to penetrate into the window pits. BEH staff could not determine whether drains exist in the bottom of each window pit to provide adequate water drainage.

**Window Pit**

- a. Repair the cement lined window pits so each seam is sealed and the floor has

proper drainage. If no drains exist, then consider placing a properly installed awning/roof system above each cement-lined window pit to direct water away from window opening and admit light to the restrooms.

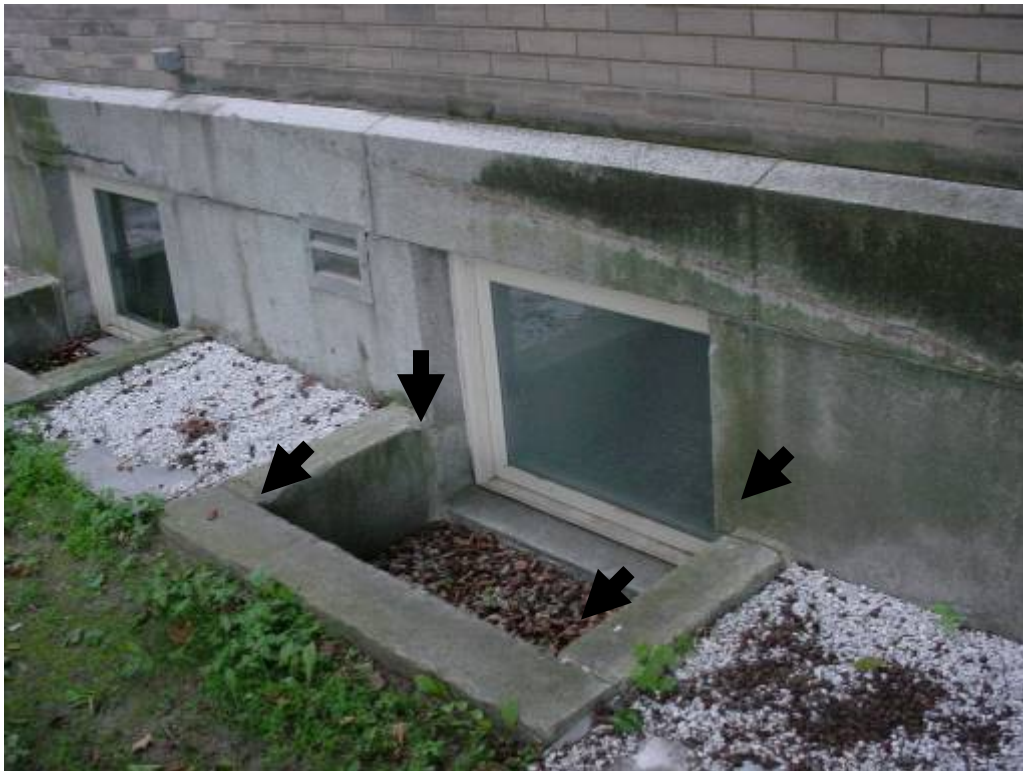
**Picture 21**

**Window Pit, Note Seams between Slabs and Foundation**

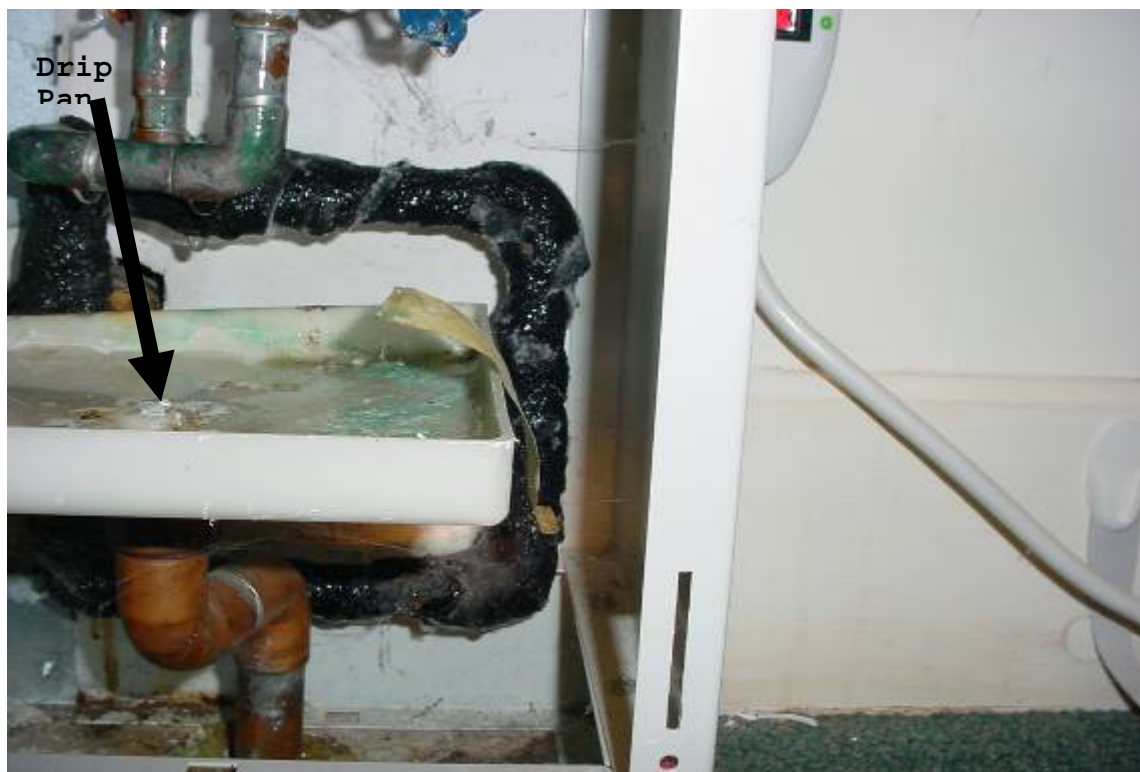
**Picture 22**

BEH staff examined the interior of FCUs in a number of locations. FCUs provide both heating and air-conditioning and are equipped with drip pans to collect and drain condensation from cooling coils. When warm, moist air passes over a surface that is cooler than the air, water condensation can collect on the cold surface. Over time, water droplets can form, which can then drip from a suspended surface. The pipes that supply chilled water for the FCUs had water droplets on the outside of the pipe insulation (Picture 22). These pipes are *outside or below* the condensation drain pan. The presence of condensation indicates that the pipe insulation is not adequate in preventing condensation formation on the pipes. Water damage noted on floors and carpeting around each FCU is likely the result of condensation drippage from these pipes (Picture 23).

**Condensation on Chilled Water Pipes inside FCU**

4. Ensure all pipes that carry chilled water in the HVAC system are properly insulated with a material of a sufficient R Rating<sup>1</sup> to prevent condensation.

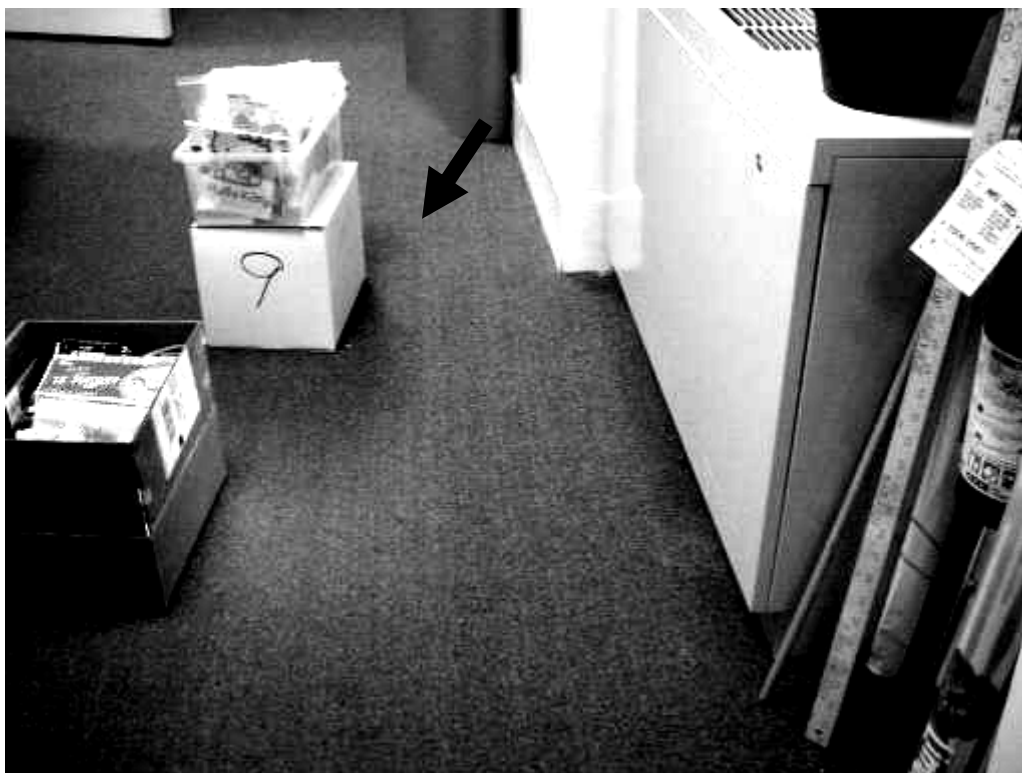
**Picture 23**

**Water Damage to Carpeting**

3. Replace carpeting on the ground floor with a non-porous material (e.g., non-slip tile) in areas subject to repeated water damage. If carpeting is necessary, use an area carpet that can be easily be replaced if damaged.

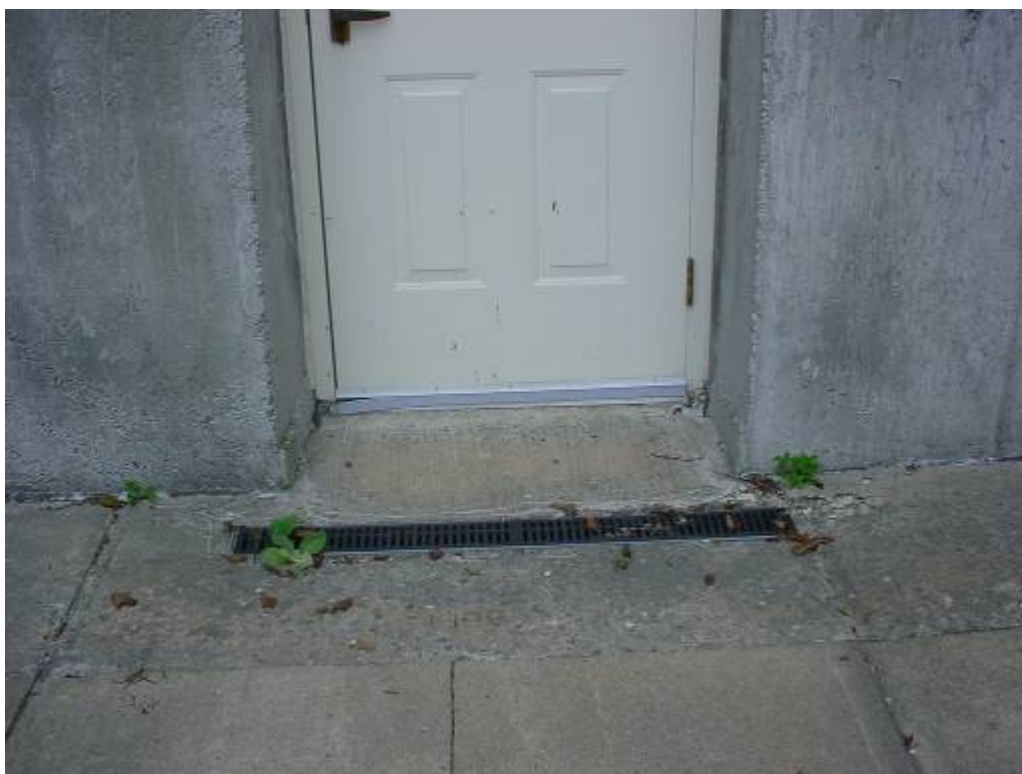
**Picture 24**

Chronic water penetration also appears to be a problem in the vicinity of the lower level exterior door on the east wall of the 1997 wing. There appears to be minimal slope to the sidewalk, which would make the door prone to water penetration during easterly-driven rain events. A drain appears to be retrofitted in front of this door (Picture 24), but is not installed at the door threshold. This may allow for rain to penetrate through the door around the drain and through spaces under the door (Picture 25).

**Drain In Front of East Exterior Door, Note Spaces around Drain, Crack in Cement**

5. Extend the drain in front of the east exterior wall door to a length that covers the entire length of the door sill.
6. Consider reconfiguring the HVAC system in the following manner:

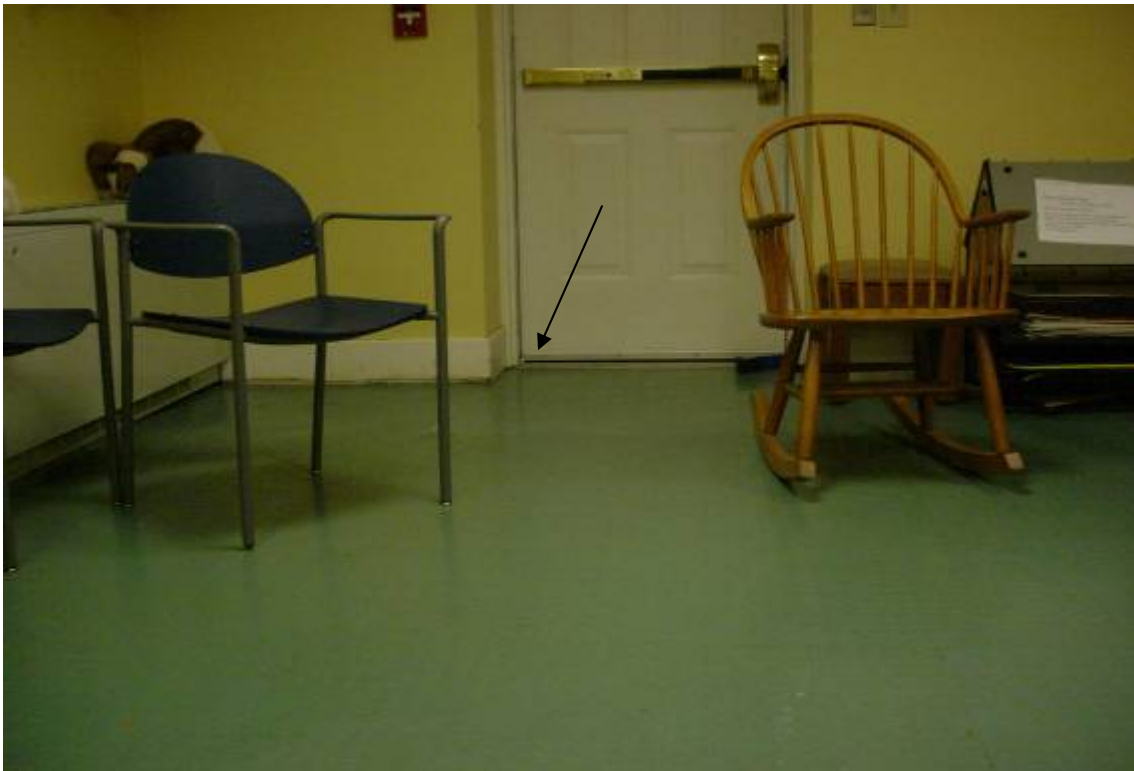
**Picture 25**

**Space in Exterior Door, East Wall**

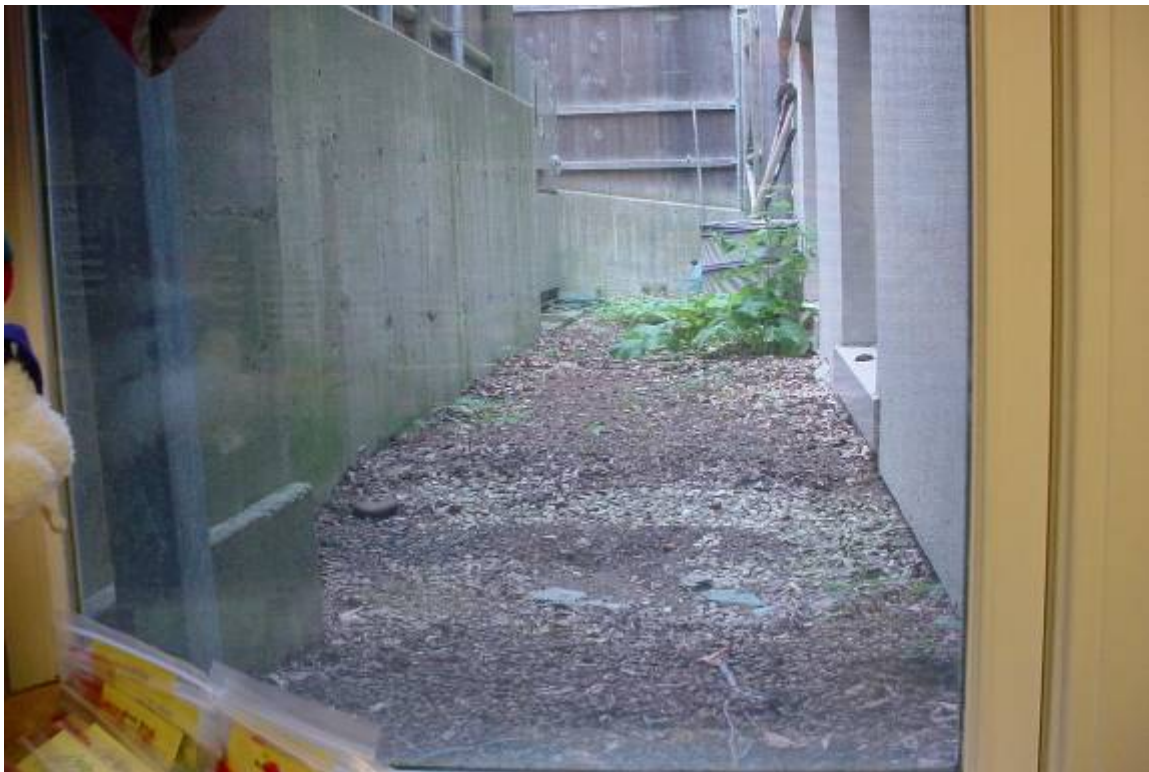
**Picture 26**

**Ground Sloped Toward Building with No Apparent Drainage**

4. Re-grade the area shown in Picture 26 in a manner that directs water away from the building or install drainage of an adequate capacity prevents water accumulation in this area.

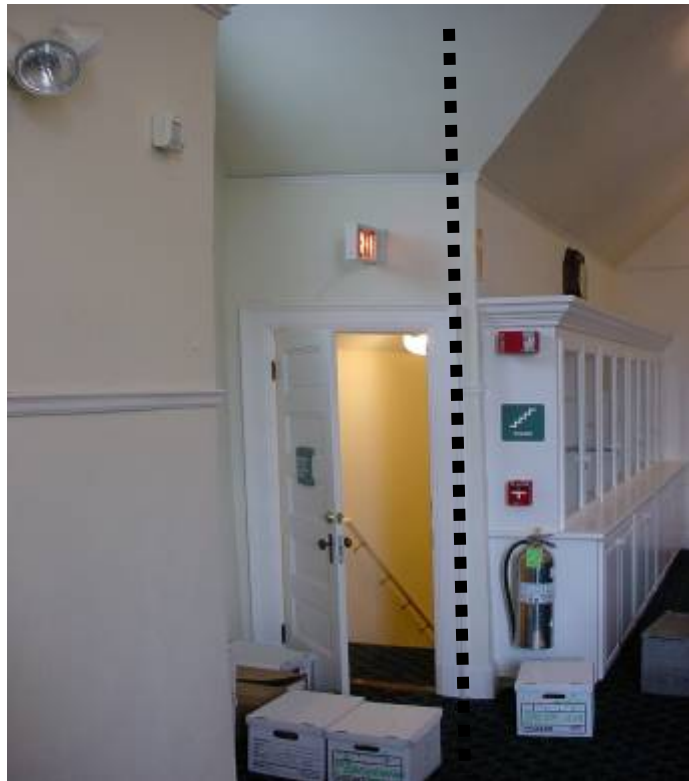
**Picture 27**

BEH staff noted a number of cracks on the wall and ceiling plaster in the Eloranta Room of the original building. In addition, several plaster walls around the south section of the Eloranta Room appeared to be both compressed and bowing (Picture 27). BEH staff examined the roof from the exterior and noted a pronounced downward bowing in the ridge of the original building's roof to the center of the roof line (Picture 28), as well as an outward bowing in the cornice of the southeast corner of the building. Based on these observations, it appears that a significant weight is pulling at the center of the original building's roof. The most likely source of this weight is the AHU equipment and false ceiling, which were retrofitted beneath the roof peak in the Eloranta Room. A report by Linn Associates, Inc. indicates that "[s]everal of the old roof rafters were cut to make room for new HVAC ductwork" (LAI, 2007).

The roof of the original building has slate shingles, which are significantly heavier than asphalts or other modern roofing materials. In addition, the roof of the original building was designed to support the weight of the slate roof and the snow load typical for the area; such support is contingent on a full compliment of original rafters. The removal of the original rafters would serve to undermine the ability of the roof to carry the weight, or deadload, of the roof structure as well as load created by accumulating snow on the roof. The renovations, which included installation of AHU, associated ductwork and the attic floor, created additional weight to an already load-compromised roof. This compounding weight load coupled with the removal of supporting rafters has likely caused instability, resulting in a variety of damage (i.e. bowing, cracking) noted in the original building.

**Bowing Wall in Eloranta Room (Dotted Line Inserted For Reference)**

1. Continue with efforts to repair the roof and exterior walls of the original building.  
Further damage to the building envelope will likely lead to leaks through the roof or exterior walls.
